UNITED STATES ENVIRONMENTAL PROTECTION AGENCY
REGION IX

Purpose: RCRA Compliance Evaluation Inspection

Facility: Island Recycling, Inc.

Date of Inspection: June 27, 2014
Time In / Time Out 1:14 pm / 3:30 pm

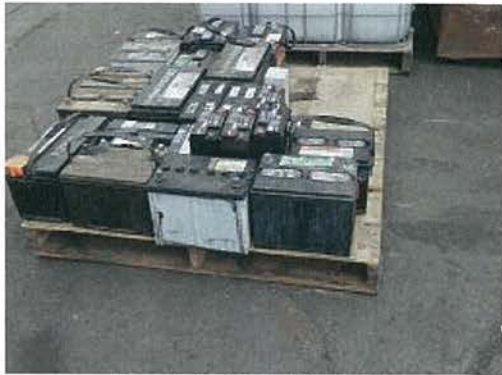
Observation	Photograph
<p>1. EPA observed two pallets of universal waste batteries that were not properly marked or dated in Yard #1 of IRI's facility. One of the pallets was observed in IRI's Customer Parking Area and the other pallet was observed on a trailer truck, in the facility's Truck Loading Area.</p>

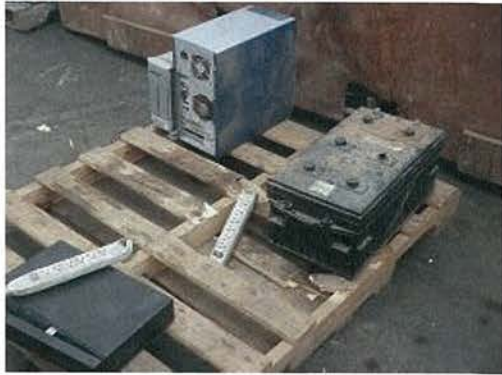
<p>No. 1 (P6270165.JPG)</p>
<p>2. EPA observed a broken battery sitting in IRI's Customer Parking Area (Yard #1). The facility failed to conduct a waste determination on the broken battery and therefore did not containerize the waste to prevent releases, mark the waste to identify the material as a hazardous waste or date the waste to indicate how long the waste had been stored on-site.</p>

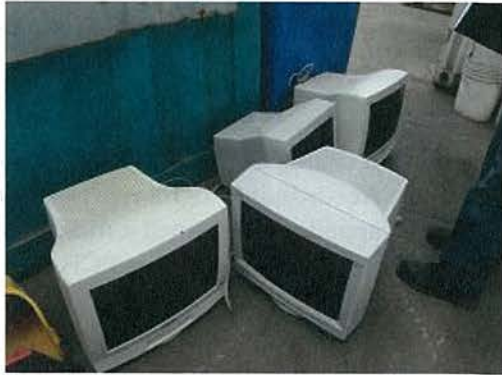
<p>No. 3 (P6270170.JPG)</p>

<p>No. 2 (P6270166.JPG)</p>
<p>3. EPA observed four monitors in IRI's Customer Parking Lot Area (Yard #1). The CRT monitors were not broken and being accumulated for purposes of recycling. The CRTs were not marked to identify the equipment as such or managed as required by law. IRI sends its CRTs to California for recycling.</p>

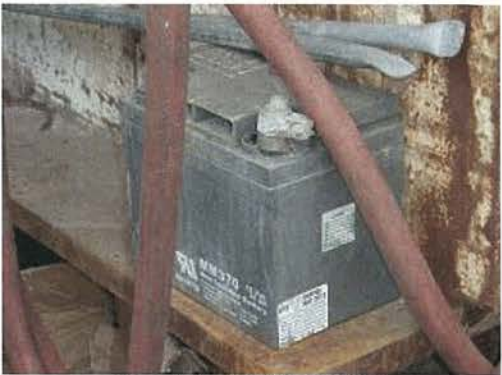
<p>No. 4 (P6270182.JPG)</p>

Observation	Photograph
<p>4. EPA observed two Universal Waste Batteries stored in Yard #1, that were not being used while on-site. One of the batteries was observed in a pile of scrap metal, electronics and wires, while the other battery was observed sitting on a ledge near the facility's Truck Loading Area. The batteries were not properly marked or dated to indicate how long the waste had been accumulated on-site.</p>

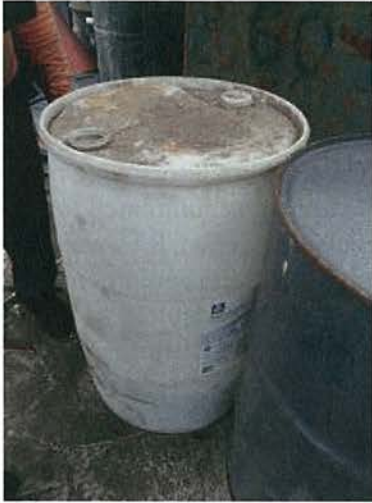
<p>No. 1 (P6270190.JPG)</p>

Observation	Photograph
<p>1. EPA observed two unmarked 55-gallon drums of small capacitors on-site. According to IRI's representative the capacitors contained a mixture of PCB (≥ 50 ppm) and non-PCB capacitors.</p>

1. EPA observed two 55-gallon containers of small capacitors on-site. IRI reports that the small capacitors contained a mix of PCB and non-PCB regulated capacitors on-site. EPA recommends that IRI either not accept PCB containing small capacitors on-site or manage the mixture of PCB and non-PCB small capacitor containers as PCB regulated waste moving forward.
2. The EPA inspector observed at least two areas on the ground in the Used Oil Storage Area that were covered with oily absorbent material from oil spills. EPA recommends that IRI minimize its releases of used oil on-site and cleanup all oily absorbent areas.

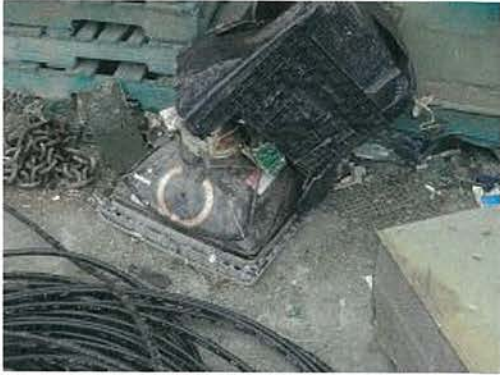
<p>No. 2 (P6270221.JPG)</p>
<p>3. EPA observed oily absorbent material on the ground in at least two areas of IRI's Used Oil Storage Area.</p>

Observation	Photograph
<p>2. EPA observed one broken CRT in Yard #2 of the IRI facility. The CRT was not properly containerized, or marked to indicate the presence of a broken CRT monitor on-site.</p>

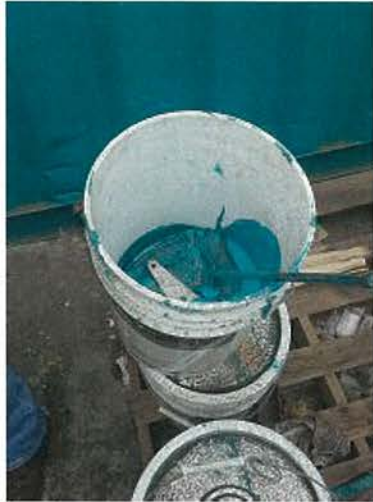
Observation	Photograph
<p>4. EPA observed one open 5-gallon container of paint waste (non-hazardous waste) and two closed 5-gallon containers of paint product on-site. None of the three containers were marked to indicate whether they were a product or a waste.</p>

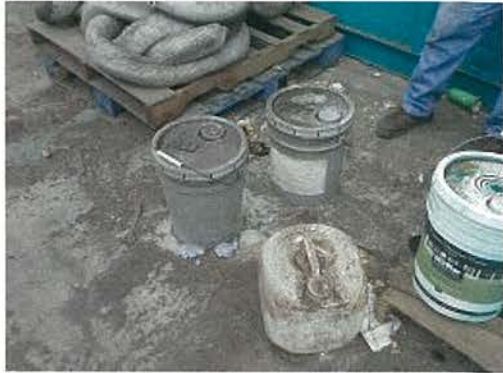
<p>No. 4 (20140627_142540.JPG)</p>
<p>5. EPA observed three unlabeled 1-gallon containers of unknown material near IRI's Used Oil Storage Area. According to IRI, two of the containers contained paint primer (non-hazardous waste) product. The third container contained an unknown substance marked with a corrosive label. IRI later managed the unknown container as a corrosive hazardous waste liquid (D002 waste).</p>

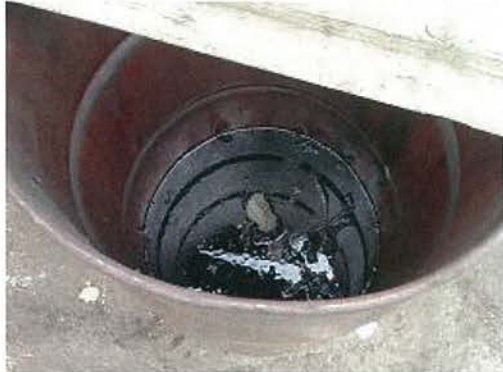
<p>No. 6 (20140627_143546.JPG)</p>

<p>No. 5 (20140627_142606.JPG)</p>
<p>6. EPA observed two open 55-gallon drums of used oil that were not marked with the words "Used Oil." In addition, EPA also documented three open small plastic pans of used oil in in Yard #2 that were also not marked with the words "Used Oil" as required by law.</p>

NO.	STATUTE OR REGULATION	REGULATION SUMMARY	FINDING(s)	FACILITY RESPONSE
7	HAR § 11-279-22(c)(1) [40 CFR § 279.22(c)(1)]	Containers and aboveground tanks used to store used oil at generator facilities must be labeled or marked clearly with the words "Used Oil."	<p>1. EPA observed two 55-gallon containers of used oil in Yard #2 of IRI's facility that were not marked with the words "Used Oil," as required under RCRA.</p> <p>2. EPA observed three plastic pans of used oil in Yard #2 of IRI's facility that were not marked with the words "Used Oil," as required under RCRA.</p>	<p>1. IRI returned to compliance with this violation on or about September 12, 2014.</p> <p>2. IRI returned to compliance with this violation on or about September 12, 2014.</p>

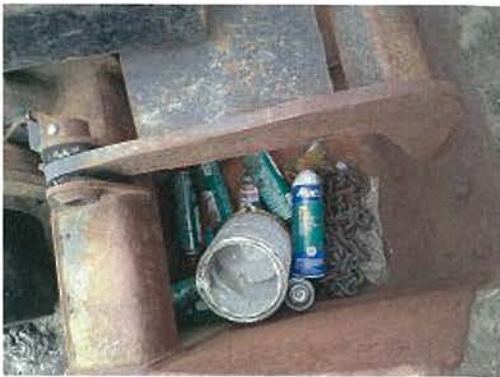
<p>No. 7 (20140627_144409.JPG)</p>

Observation	Photograph
<p>7. EPA observed several aerosol cans (D001 and D003 waste) thrown in several metal piles all around Yard #2. The cans were placed there for the purposes of recycling of the metal. The aerosol cans were not totally empty nor punctured, and therefore regulated for disposal under RCRA. At the time of EPA's inspection, IRI had not identified the cans as a potential RCRA waste stream on-site. Nor had it manifested the waste off-site for disposal previously.</p>

During EPA's 2014 inspection, EPA identified wastes in the form of aerosol cans (D001 and D003 waste) and broken batteries (D008 waste) that had not been previously identified as hazardous at IRI. As such, once IRI failed to make a waste determination of all its hazardous waste streams on-site, the facility became subject to the generator storage, record keeping and reporting requirements under RCRA. However, due to the fact that the facility had not manifested hazardous waste off previously, it is difficult to determine IRI's true generator status.

Since the inspection, IRI has collected all of its aerosol cans on-site and consolidated them into four 55-gallon drums worth of hazardous waste.

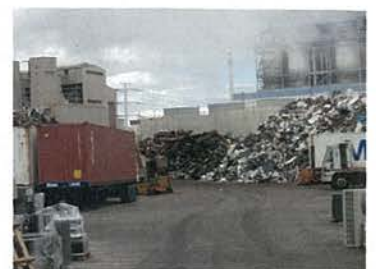
P6270213.JPG
6/27/2014

IMG_P6270213.JPG 6/27/2014	Photo of three weather worn cardboard boxes marked "1993 HRS Replacement Volumes 8-14" in Yard #2 of IRI's facility.
IMG_P6270214.JPG 6/27/2014	Photo of IRI's Yard #2 looking Northeast.
IMG_P6270215.JPG 6/27/2014	Photo of a 5-gallon container of paint primer in Yard #2 of IRI's facility.
IMG_P6270216.JPG 6/27/2014	Photo of H-Power's shredded and burnt ferrous metal in Yard #2 of IRI's facility.
IMG_P6270217.JPG 6/27/2014	A close up photo of H-Power's shredded and burnt ferrous metal in Yard #2 of IRI's facility.
IMG_P6270218.JPG 6/27/2014	Photo of additional scrap metal and electronics in Yard #2 of IRI's facility.
IMG_P6270219.JPG 6/27/2014	Photo of old cabling and electronics in Yard #2 of IRI's facility.
IMG_P6270220.JPG 6/27/2014	Photo of a broken CRT monitor in Yard #2 of IRI's facility.

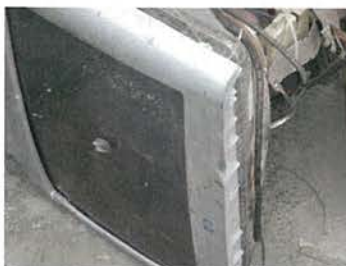
P6270221.JPG
6/27/2014

IMG_P6270221.JPG 6/27/2014	A close up photo of the broken CRT monitor in Yard #2 of IRI's facility.
IMG_P6270222.JPG 6/27/2014	Another close up of photo of the broken CRT monitor in Yard #2 of IRI's facility.
IMG_P6270223.JPG 6/27/2014	Photo of scrap wire and cabling in Yard #2 of IRI's facility.
IMG_P6270224.JPG 6/27/2014	Another photo of the 5-gallon container of paint primer in Yard #2 of IRI's facility.
IMG_P6270225.JPG 6/27/2014	Photo of a door marked "Motor Oil" in Yard #2 of IRI's facility.
IMG_P6270226.JPG 6/27/2014	Photo of a door marked "Coolant" in Yard #2 of IRI's facility.
IMG_P6270227.JPG 6/27/2014	Photo of aerosol cans (product) being stored on shelves in Yard #2 of IRI's facility.
20140627_141949.JPG 6/27/2014	Photo of an open 1-gallon container of unknown liquid in Yard #2 of IRI's facility.
20140627_142000.JPG 6/27/2014	Photo of an open, unmarked and unknown tank of red and blue liquid in Yard #2 of IRI's facility.
